RECENT MASS MOVEMENTS IN SLOVENIA

Matija Zorn
Blaž Komac

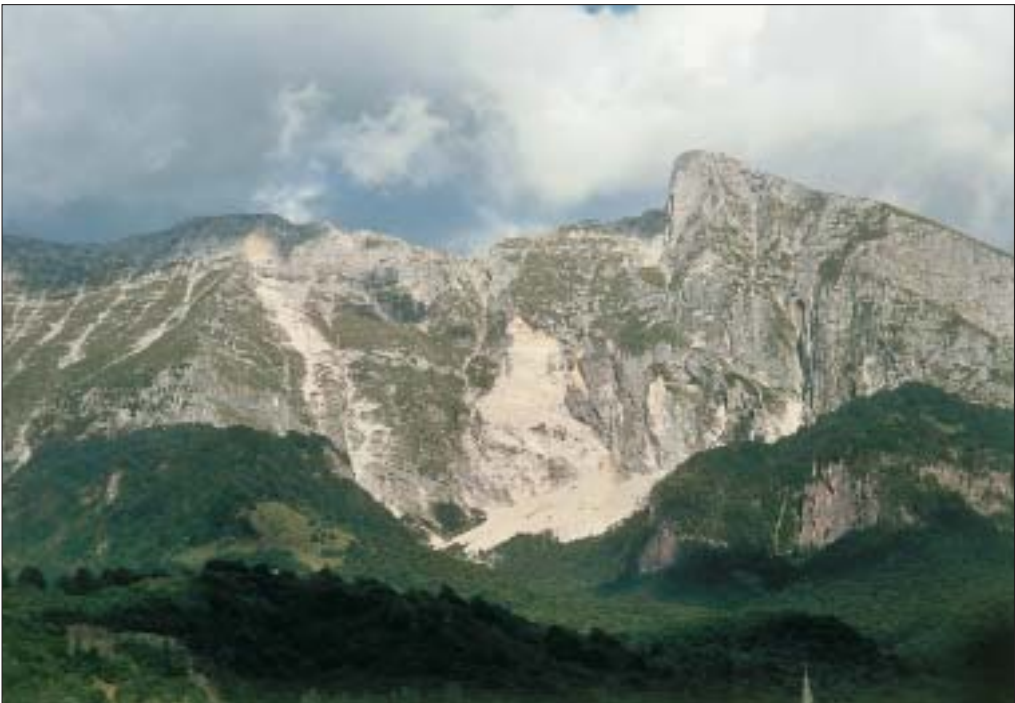
Figure 2: Rockfalls on Mount Krn (photography Matija Zorn).

The rockfalls occurred in uninhabited and hard to reach areas several hundred meters above the bottoms of valleys. Their number increased with their relative altitude because the horizontal acceleration and amplitude of seismic waves increase with altitude. The rockfalls did not affect people but only caused some damage to mountain pastures and mountain trails. The largest rockfalls occurred in the southwestern wall of Mount Krn (2,244 m), where rockfall material was deposited over fifteen hectares, and on Mount Osojnica above the valley of the Tolminka River (30 hectares; Natek et al. 2003).

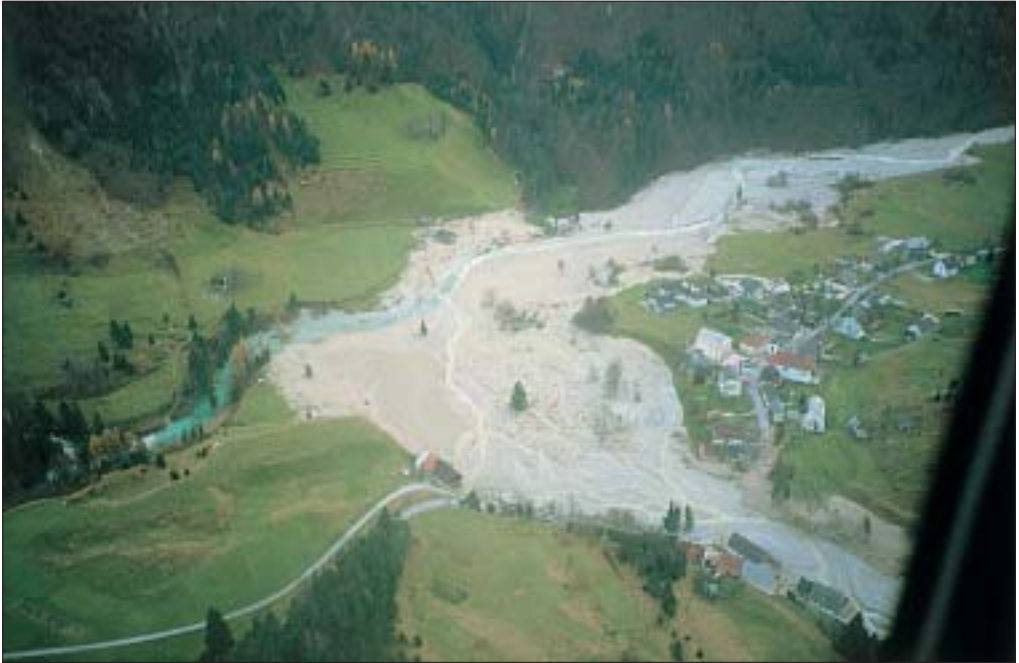
Figure 3: Fan of the debris flow in Log pod Mangartom (photography Blaž Komac).

A landslide (2,500,000 m³) was triggered west of Mount Mangart (2,679 m) on November 15, 2000, between 1,340 and 1,580 meters above sea level that stopped in the valley of the Mangartski potok stream. Due to the abundance of water it carried with it, a debris flow occurred on November 17, 2000, that took seven lives and destroyed several houses and outbuildings in Log pod Mangartom. New houses were built for the stricken inhabitants, and the construction of safety barriers above the village is planned because the material remaining in the slide area is not stable.

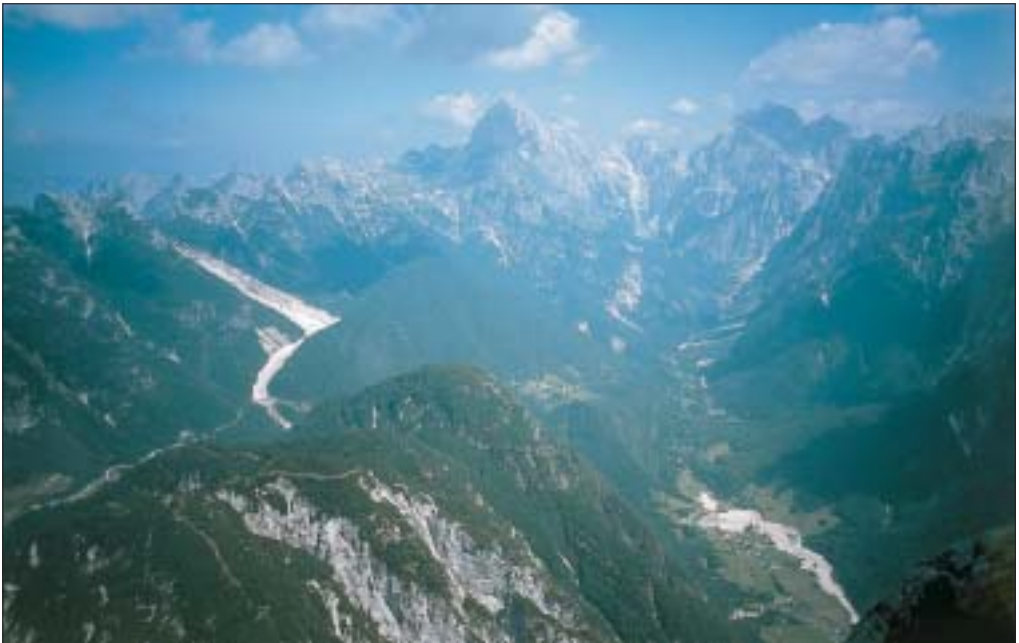
Figure 4: The Stovžje landslide on the left and the alluvial fan of the debris flow in Log pod Mangartom on the right with Mount Mangart in the middle (photography Matija Zorn).

In both cases, the main cause of sliding was the Tamar rock formation (alternating layers of sandstone, claystone, limestone, and dolomite) or its weathered debris (clay minerals) that swells when soaked. The parallel incidence of the rock layers also contributed to the movement.

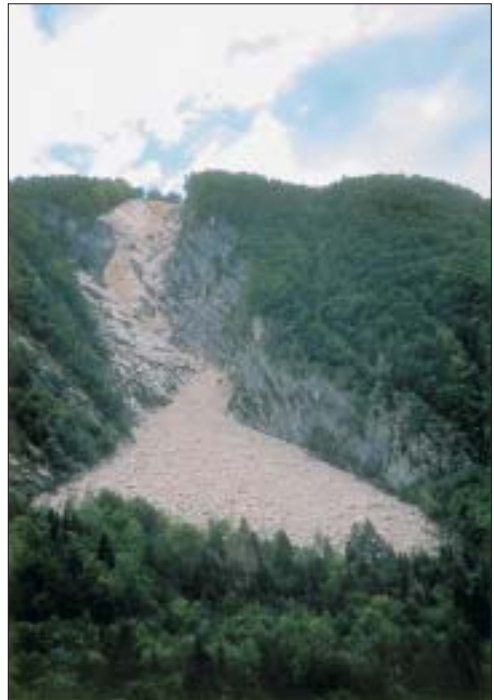
Figure 5: Wedge-shaped rockslide in the Lepena Valley triggered by the earthquake on April 12, 1998 (photography Matija Zorn).
