# RECENT MASS MOVEMENTS IN SLOVENIA

# Matija Zorn Blaž Komac

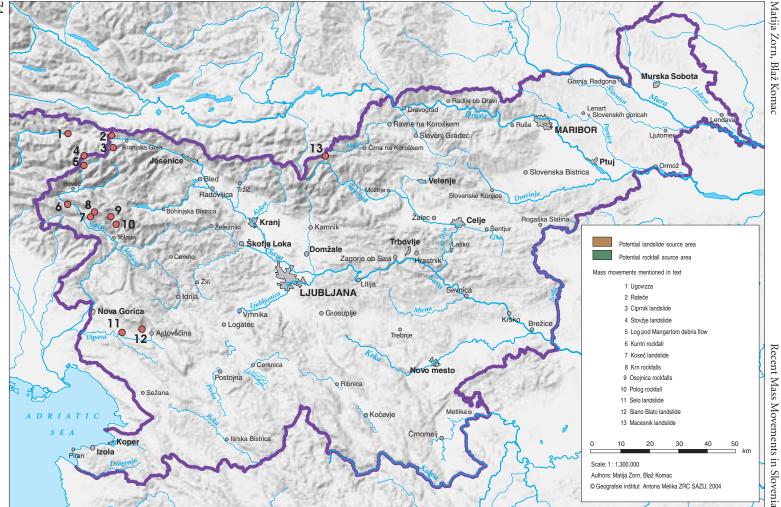
### ▼ Figure 1: Potential landslide and rockfall source areas in Slovenia.

Table 1: Potential landslide and rockfall source areas in Slovenia.

Area [km²]	Percentage of total surface	
Potential landslide source areas	1,214.2	6.0	
Potential rockfall source areas	699.9	3.5

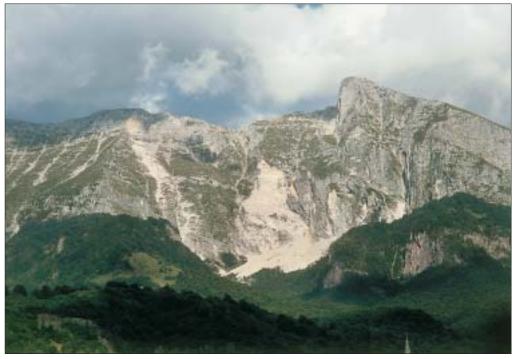
Figure 2: Rockfalls on Mount Krn (photography Matija Zorn).

Kozjansko on June 20, 1974; and the Friuli earthquake in Italy on May 6, 1976. The appearance of the landscape was also changed by the earthquake in the upper Soča Valley on April 12, 1998 (M: 5.8; I: VII–VIII EMS), which had its hypocenter at a depth of eight kilometers and triggered more than one hundred rockfalls of various sizes. Several million cubic meters of material were moved (Ribičič and Vidrih 1998).

The rockfalls occurred in uninhabited and hard to reach areas several hundred meters above the bottoms of valleys. Their number increased with their relative altitude because the horizontal acceleration and amplitude of seismic waves increase with altitude. The rockfalls did not affect people but only caused some damage to mountain pastures and mountain trails. The largest rockfalls occurred in the southwestern wall of Mount Krn (2,244 m), where rockfall material was deposited over fifteen hectares, and on Mount Osojnica above the valley of the Tolminka River (30 hectares; Natek et al. 2003).

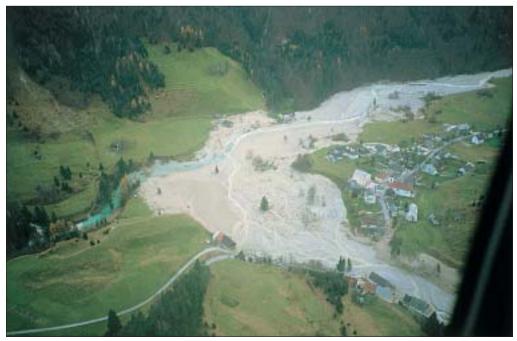
Figure 3: Fan of the debris flow in Log pod Mangartom (photography Blaž Komac).

A landslide (2,500,000 m³) was triggered west of Mount Mangart (2,679 m) on November 15, 2000, between 1,340 and 1,580 meters above sea level that stopped in the valley of the Mangartski potok stream. Due to the abundance of water it carried with it, a debris flow occurred on November 17, 2000, that took seven lives and destroyed several houses and outbuildings in Log pod Mangartom. New houses were built for the stricken inhabitants, and the construction of safety barriers above the village is planned because the material remaining in the slide area is not stable.

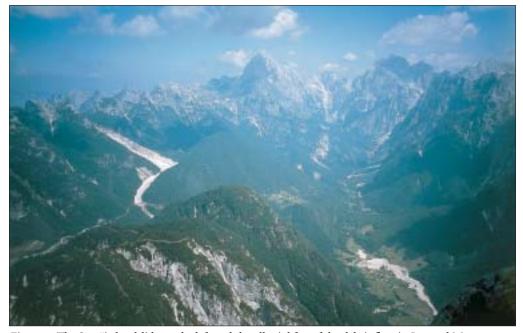
Figure 4: The Stovžje landslide on the left and the alluvial fan of the debris flow in Log pod Mangartom on the right with Mount Mangart in the middle (photography Matija Zorn).

In both cases, the main cause of sliding was the Tamar rock formation (alternating layers of sandstone, claystone, limestone, and dolomite) or its weathered debris (clay minerals) that swells when soaked. The parallel incidence of the rock layers also contributed to the movement.

Heavy precipitation triggered both slides. In November 2000, 1,234 mm of rain (50% of the annual average) fell in Log pod Mangartom. Debris flows of larger dimensions occurred in the vicinity of Bovec and in the Planica Valley in the Pleistocene. In the historical period, place names and historical sources mentioning similar events 300 and 110 years ago also reveal their occurrence (Zorn and Komac 2002).

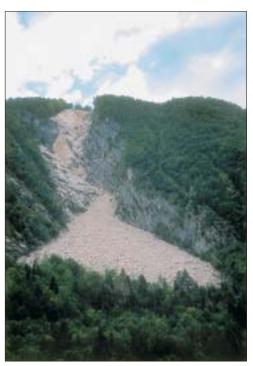
Figure 5: Wedge-shaped rockslide in the Lepena Valley triggered by the earthquake on April 12, 1998 (photography Matija Zorn).
